Uncovering Hidden Issues: How Thermal Drone Technology is Revolutionizing Roof Inspections

A recent warehouse roofing project highlights how drones equipped with infrared thermal cameras can revolutionize traditional roofing inspections.

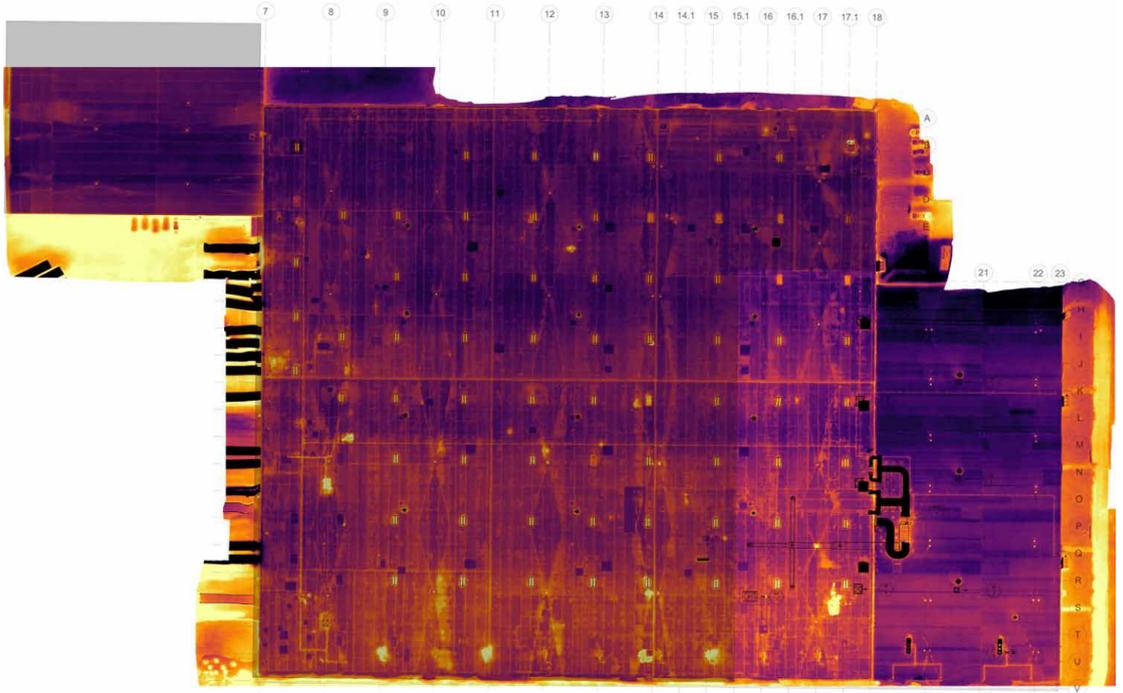
Roof: Overall Thermal Image

Columbia's Reality Capture Department deployed an infrared equipped drone to scan the entire roof of the warehouse. To fly and scan the entire roof took roughly 45 minutes. This high-tech approach allowed for the creation of a detailed thermal map of the roof. Allowing Columbia and the roofing contractor to pinpoint multiple areas of concern that were invisible to the naked eye. A plan based off the thermal data and active leak reports was developed to do physical roof openings in 4 locations across the roof.

The physical testing of the roof at the locations identified by the drone confirmed the thermal data provided by the drone. The comprehensive assessment led to the decision to replace the entire roofing system rather than continue with ineffective patch repairs.

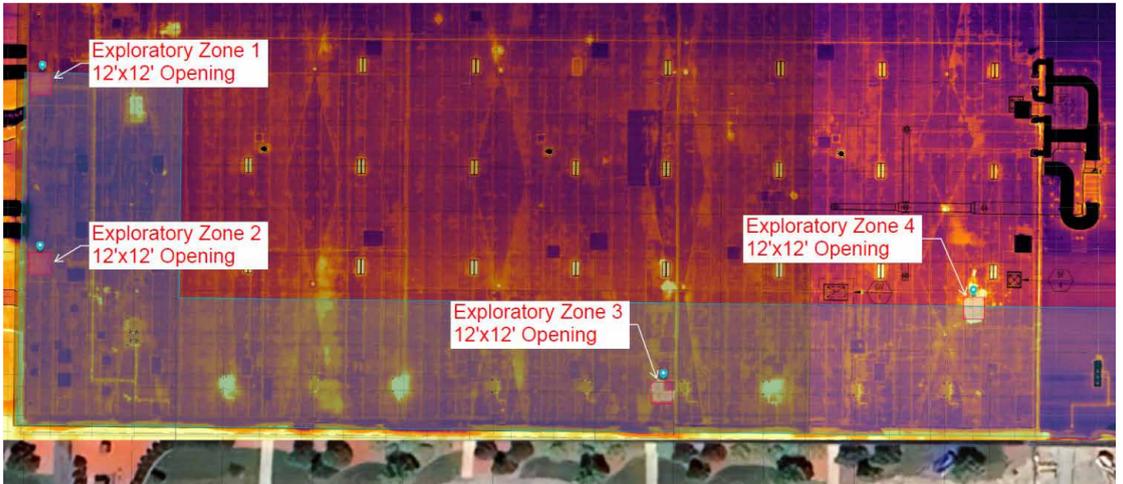
Roof: Exploratory Openings

- **Zone 1 & Zone 2:** Identified due to existing leaks inside the facility.
- **Zone 3 & Zone 4:** Marked by distinct thermal abnormalities on the infrared map.

- **Zone 1:** This area showed signs of past water damage but no current wet conditions.
- **Zone 2:** Like Zone 1, this area had acceptable conditions.
- **Zone 3:** Thermal anomaly. Revealed saturated OSB and waterlogged insulation, with ice found in the decking flutes.
- **Zone 4:** Thermal anomaly. The worst-affected area, with wet insulation and a visibly compromised original deck.

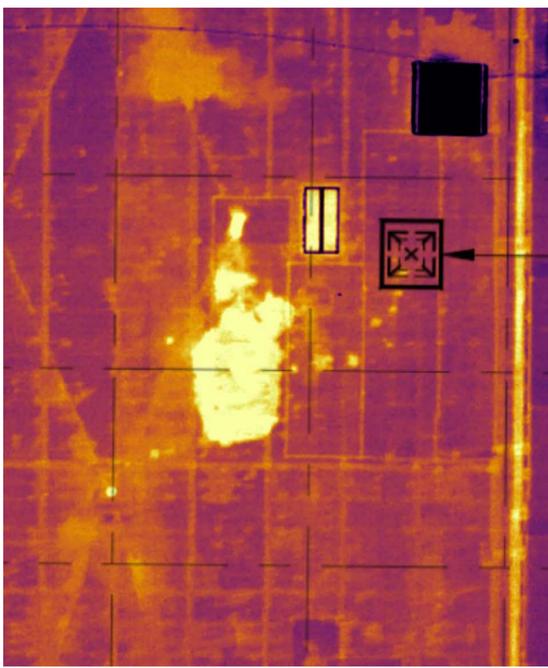
Zone #4
Image of thermal anomaly clearly shows the problem area in yellow.

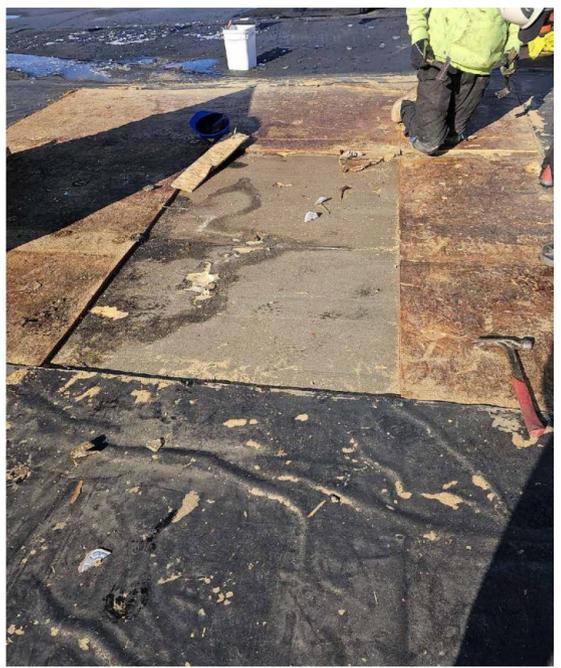
Zone #4
The OSB was removed to reveal wet insulation in areas that matched the infrared scan abnormality shape.
